A Field Study of PCC Joint Misalignment Near Fergus Falls, Minnesota

A FIELD STUDY OF PCC JOINT MISALIGNMENT NEAR FERGUS FALLS, MINNESOTA

Final Report

May 1999

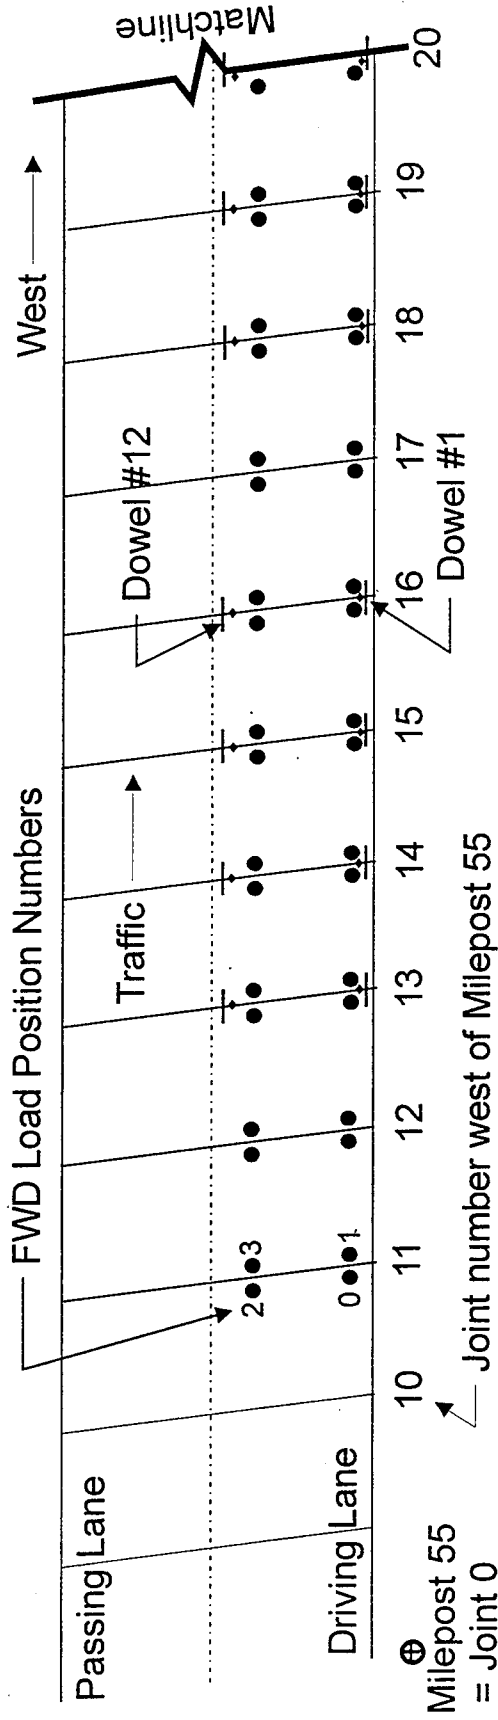
Figure 1. Test Site

Dowel bar alignment measurements were taken along fifteen selected driving lane transverse joints in the area under investigation. See Figure 1. A Proceq PROFOMETER 3 Rebar Locator was used to determine the lateral and longitudinal location of four to five of the twelve dowel bars in each joint. Dowel bars 1,2,10,11, and 12 were located; where dowel number 1 designates the dowel bar closest to the driving lane shoulder. The measurements are believed to be within ± 13 mm (± 0.5 in) of the actual location.

Faulting (vertical stepping) measurements were taken at two locations along each selected joint. See Figure 1 for locations. A Georgia type faultmeter was used to obtain the measurements. See Table 2 for results. Several of the joints have faulting in excess of 6 mm (0.25 in), with the highest reading measured at 12.8 mm (0.50 in).

Load transfer efficiency (LTE) results from each of the load positions (see Figure 1) is presented in Table 3. LTE values were calculated using the method outlined in section 3.5.4 of the *AASHTO Guide for Design of Pavement Structures (1993)*[1].

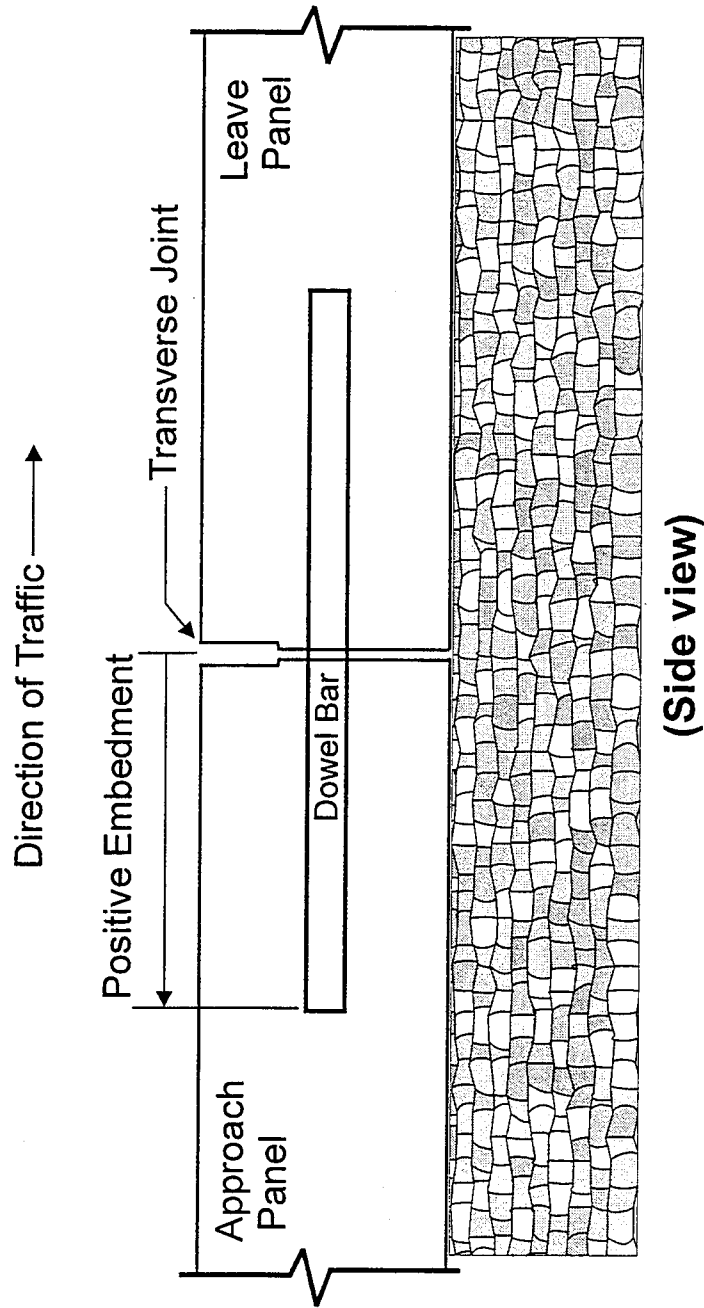
Figure 2. Embedment length notation

Based on the longitudinal measurements, dowel bar embedment lengths were determined. Table 1 clearly shows the large variation in embedment lengths found. Positive embedment values correlate to lengths on the approach panel side (see Figure 2). Figure 3 shows embedment lengths graphically. Note that embedment lengths greater than 356 mm (14 in) or less than zero are shown as zero on this graph.

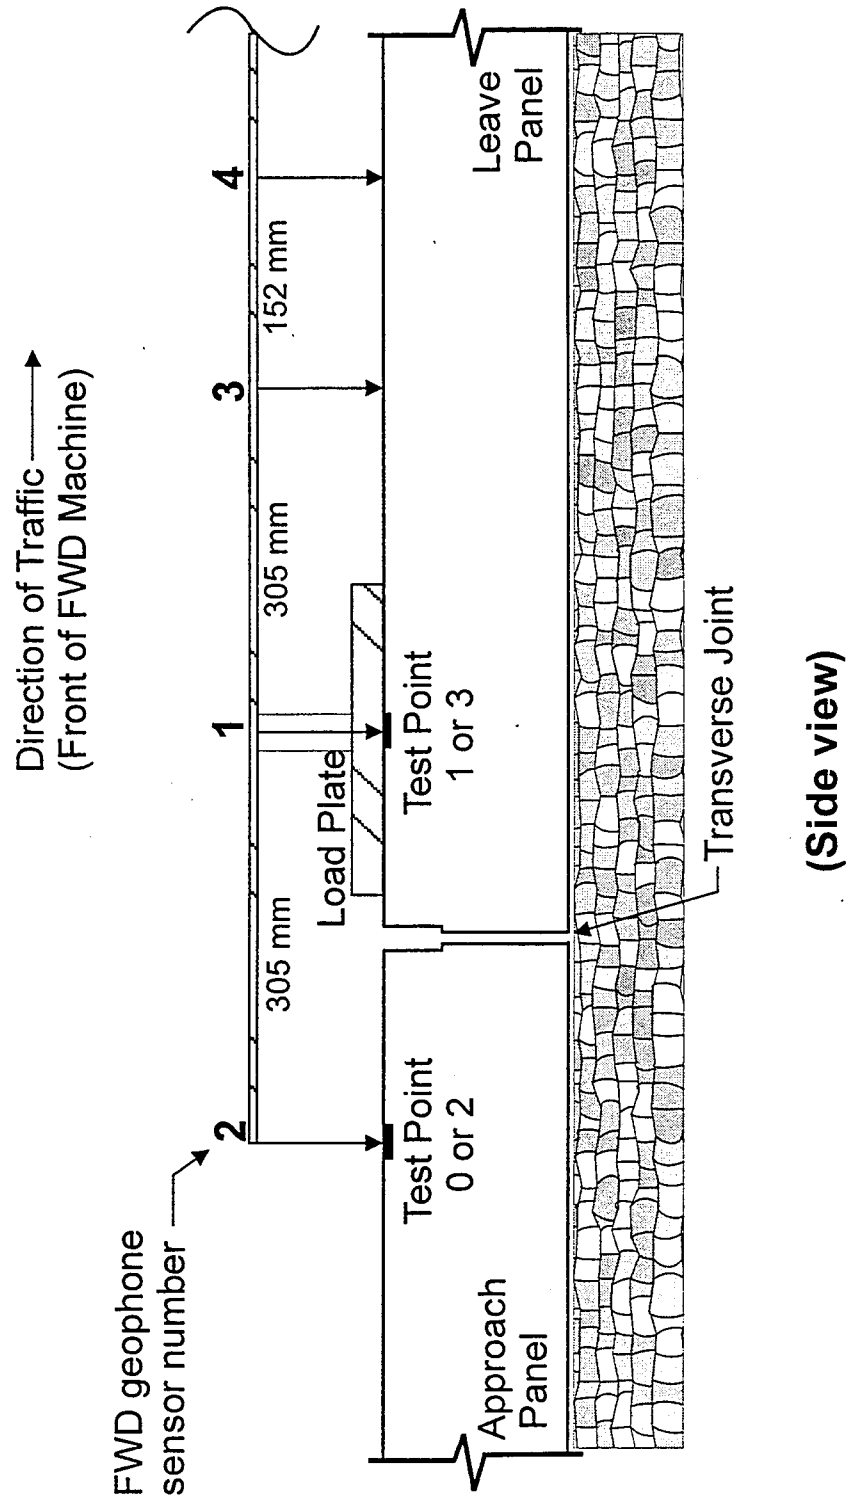
Figure 4. FWD Geophone Arrangement Scheme

The current load transfer efficiency of both the selected joints and several other joints nearby the area of study, was determined. A Dynatest Model 8000 Falling Weight Deflectometer (FWD) was used with the geophone sensors arranged as shown in Figure 4. Loading consisted of 3 drops at each load level of 26.7 kN, 40 kN, and 66.7 kN (6000, 9000, and 15000 lbs). Testing occurred from 11 AM to 2 PM, with pavement surface temperatures ranging from 2.8 to 10 °C (37 to 50 °F).
